STORMWATER MANAGEMENT PLAN

THE VILLAGE OF METTAWA

Project Number: 20-0216

May 7, 2021

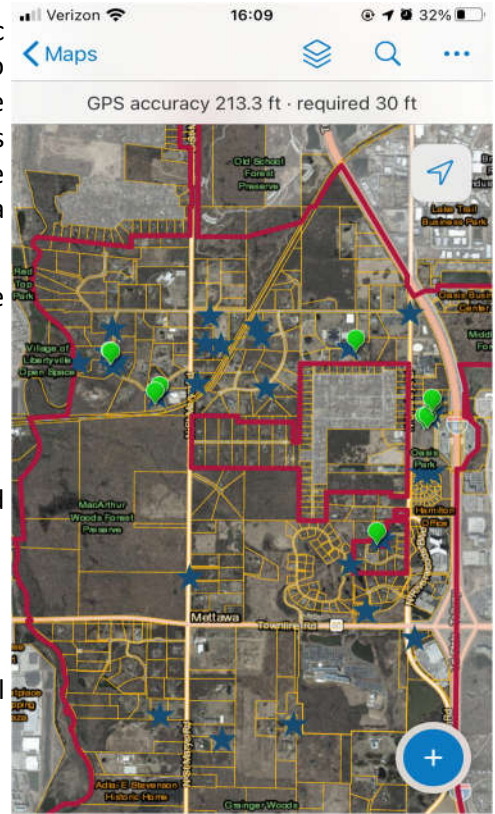
Field Data Collection Interface

Provided digital files with geographic components (engineering design plans, topographic surveys, drainage atlases, and preliminary design sketches) were geo-referenced using Lake County parcel information and Lake County 2018 high-resolution aerial imagery, projected using NAD 1983 (2011) State Plane Illinois East FIPS 1201 (US Feet). A minimum of three control points were selected for each digital file based upon visual clarity on the exhibit, visual clarity on the reference geographic data, type of object selected (preference was given to stationary objects, such as sidewalk or roadway edges of pavement), and distribution extent.

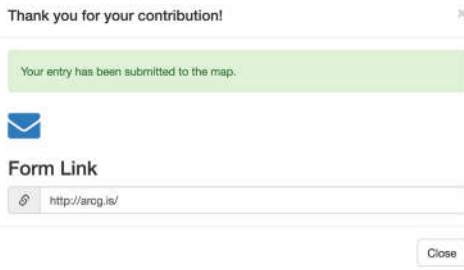
Report Submission Confirmation

* Two separate digital interfaces were created by Hey. The first was designed to provide a method of data collection for residents, the second was designed to provide the Village staff with an interface to monitor submissions. Concerns reported in the public application populated a database, which was then displayed on the administrative application. Screen captures provided in Appendix C (Drainage Concerns Application - Public and Drainage Concerns Application - Administrative sections) show the interfaces for both map interfaces. A fillable PDF form was also created and provided in the public-facing application, included in Appendix C.

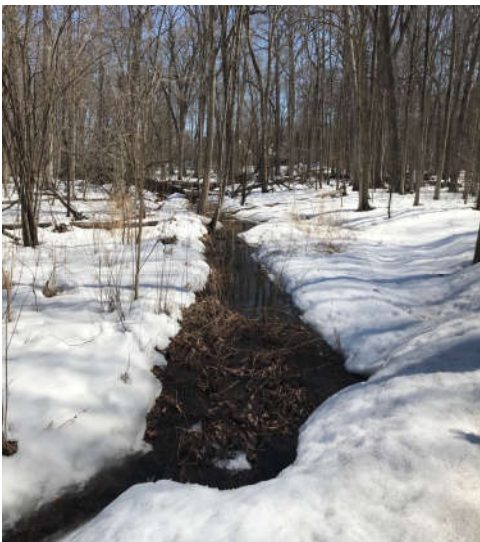
15390 W Little Saint Marys Road
Upstream Drainage

A 30-inch by 19-inch elliptical reinforced concrete pipe conveys flow under W Little Saint Marys Road, just south of W Old School Road. As shown on Schematic Design Plan C1.0, this area is impacted by the floodplain from the Des Plaines River, likely further inhibiting drainage in high water level conditions. Proximity to the Des Plaines, recent regional trends of increased rainfall depths and frequency, and topography suggest the increase in standing water in this area, predominantly east of the road, is influenced by the current high water tables. Additional investigation shows hydric and hydric inclusion soils, further suggesting this area is prone to periodic inundation.

Without an extensive analysis of stormwater storage volume in the approximately 193-acre upper watershed, preliminary drainage area delineation and reports of roadway overtopping in Reported Concern 26 suggest the existing pipe may be undersized. Preliminary model results, that excludes detailed modeling of watershed storage, suggest that the existing pipe has between 6-month and 9-month capacity (Appendix D).

Roadway elevations and associated cover available over the pipe indicate that the most practical way to increase conveyance would be to install a secondary 30-inch by 19-inch elliptical culvert, effectively doubling the current capacity. Other capacity-driven solutions may include replacement of this crossing with a bridge or box culvert, although a more costly option.

Schematic Design C1.0 depicts the recommended solution, which is to install a secondary pipe to increase capacity and accommodate larger flow events. Considering the downstream channel is experiencing erosion (Reported Concern 6), it is recommended that the downstream length of the channel, located on private property, be assessed, stabilized, and restored in conjunction with any pipe replacement to protect against future erosion. A

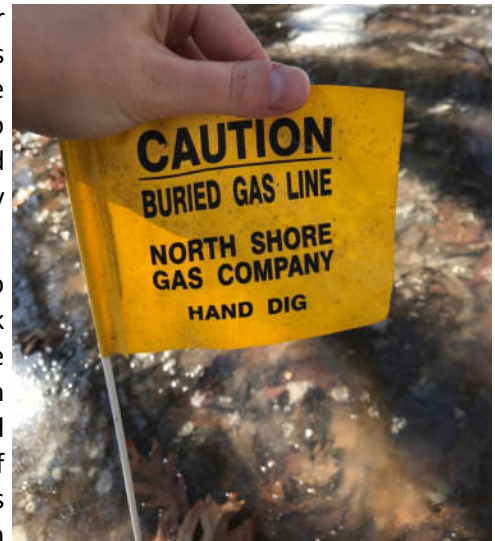
15141 W Little Saint Marys
Field Utility Flag

Across from Sapphire Riding Academy, a 12-inch corrugated metal pipe under W Little Saint Marys Road has collapsed. In the interim, a 4-inch PVC pipe was inserted into the upstream side of the culvert in an effort to maintain some level of drainage. The existing PVC pipe limits capacity, causing water to overtop W Little Saint Marys Road, impacting the road surface condition and leading to seasonal ice sheet formation. In an effort to protect public safety and Village infrastructure, it is recommended that this culvert be replaced.

Rational method and culvert capacity calculations were performed to determine if the pipe should be replaced in-kind or upsized to convey peak discharge from the approximately 1.4-acre contributing area. Results show the pipe size is limited, prompting recommendation to upsize the pipe to a 15-inch pipe. Replacement would include the installation of two new flared end sections, minor grading to improve upstream drainage, and the installation of stone outlet scour protection at the downstream flared end section and is shown in schematic design plan C3.0. A design-stage planning information request is recommended to confirm feasibility of upsizing the culvert, as field reconnaissance recovered gas pipeline utility flags in the area.

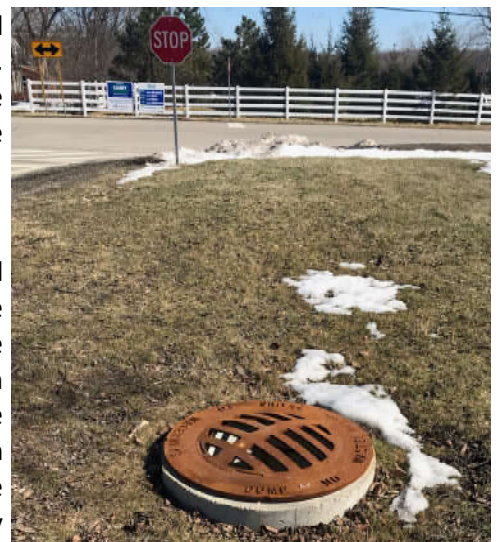
One of Three Inlets to be Modified

Three storm sewer inlets located on the southwest corner of the W Old School Road and Bradley Road intersection are slightly elevated relative to the surrounding ground surface. This minor elevation discrepancy impedes capture of overland flow from the adjacent road and trail, likely resulting in concentrated overland flow at the intersection. This could be the cause of the accumulation of the roadway debris referenced in the submitted concern. In addition, the capacity of the 15-inch outlet pipe to the south limits drainage from both the 15-inch and 12-inch pipes entering the structure, potentially causing surcharge conditions in some events.

To lower the inlet rim elevations by approximately 6-inches to match the adjacent ground elevations, the concrete grade rings should be removed, and the Type 8 grates be reset on the inlet structure. It is also recommended that the 8-foot 15-inch outlet section be removed and the inlet structure be sawcut to provide sufficient capacity to convey flows. The recommended plan also includes regrading the roadside ditch per plans by the James Anderson Company, dated July 25, 2016. Additional ditch grading is shown on the schematic design plan C5.0 to accommodate the proposed sawcut. These adjustments would likely be considered maintenance, will help preserve the integrity of the roadway and trail, and will help to keep the area free of debris resulting from ponding.

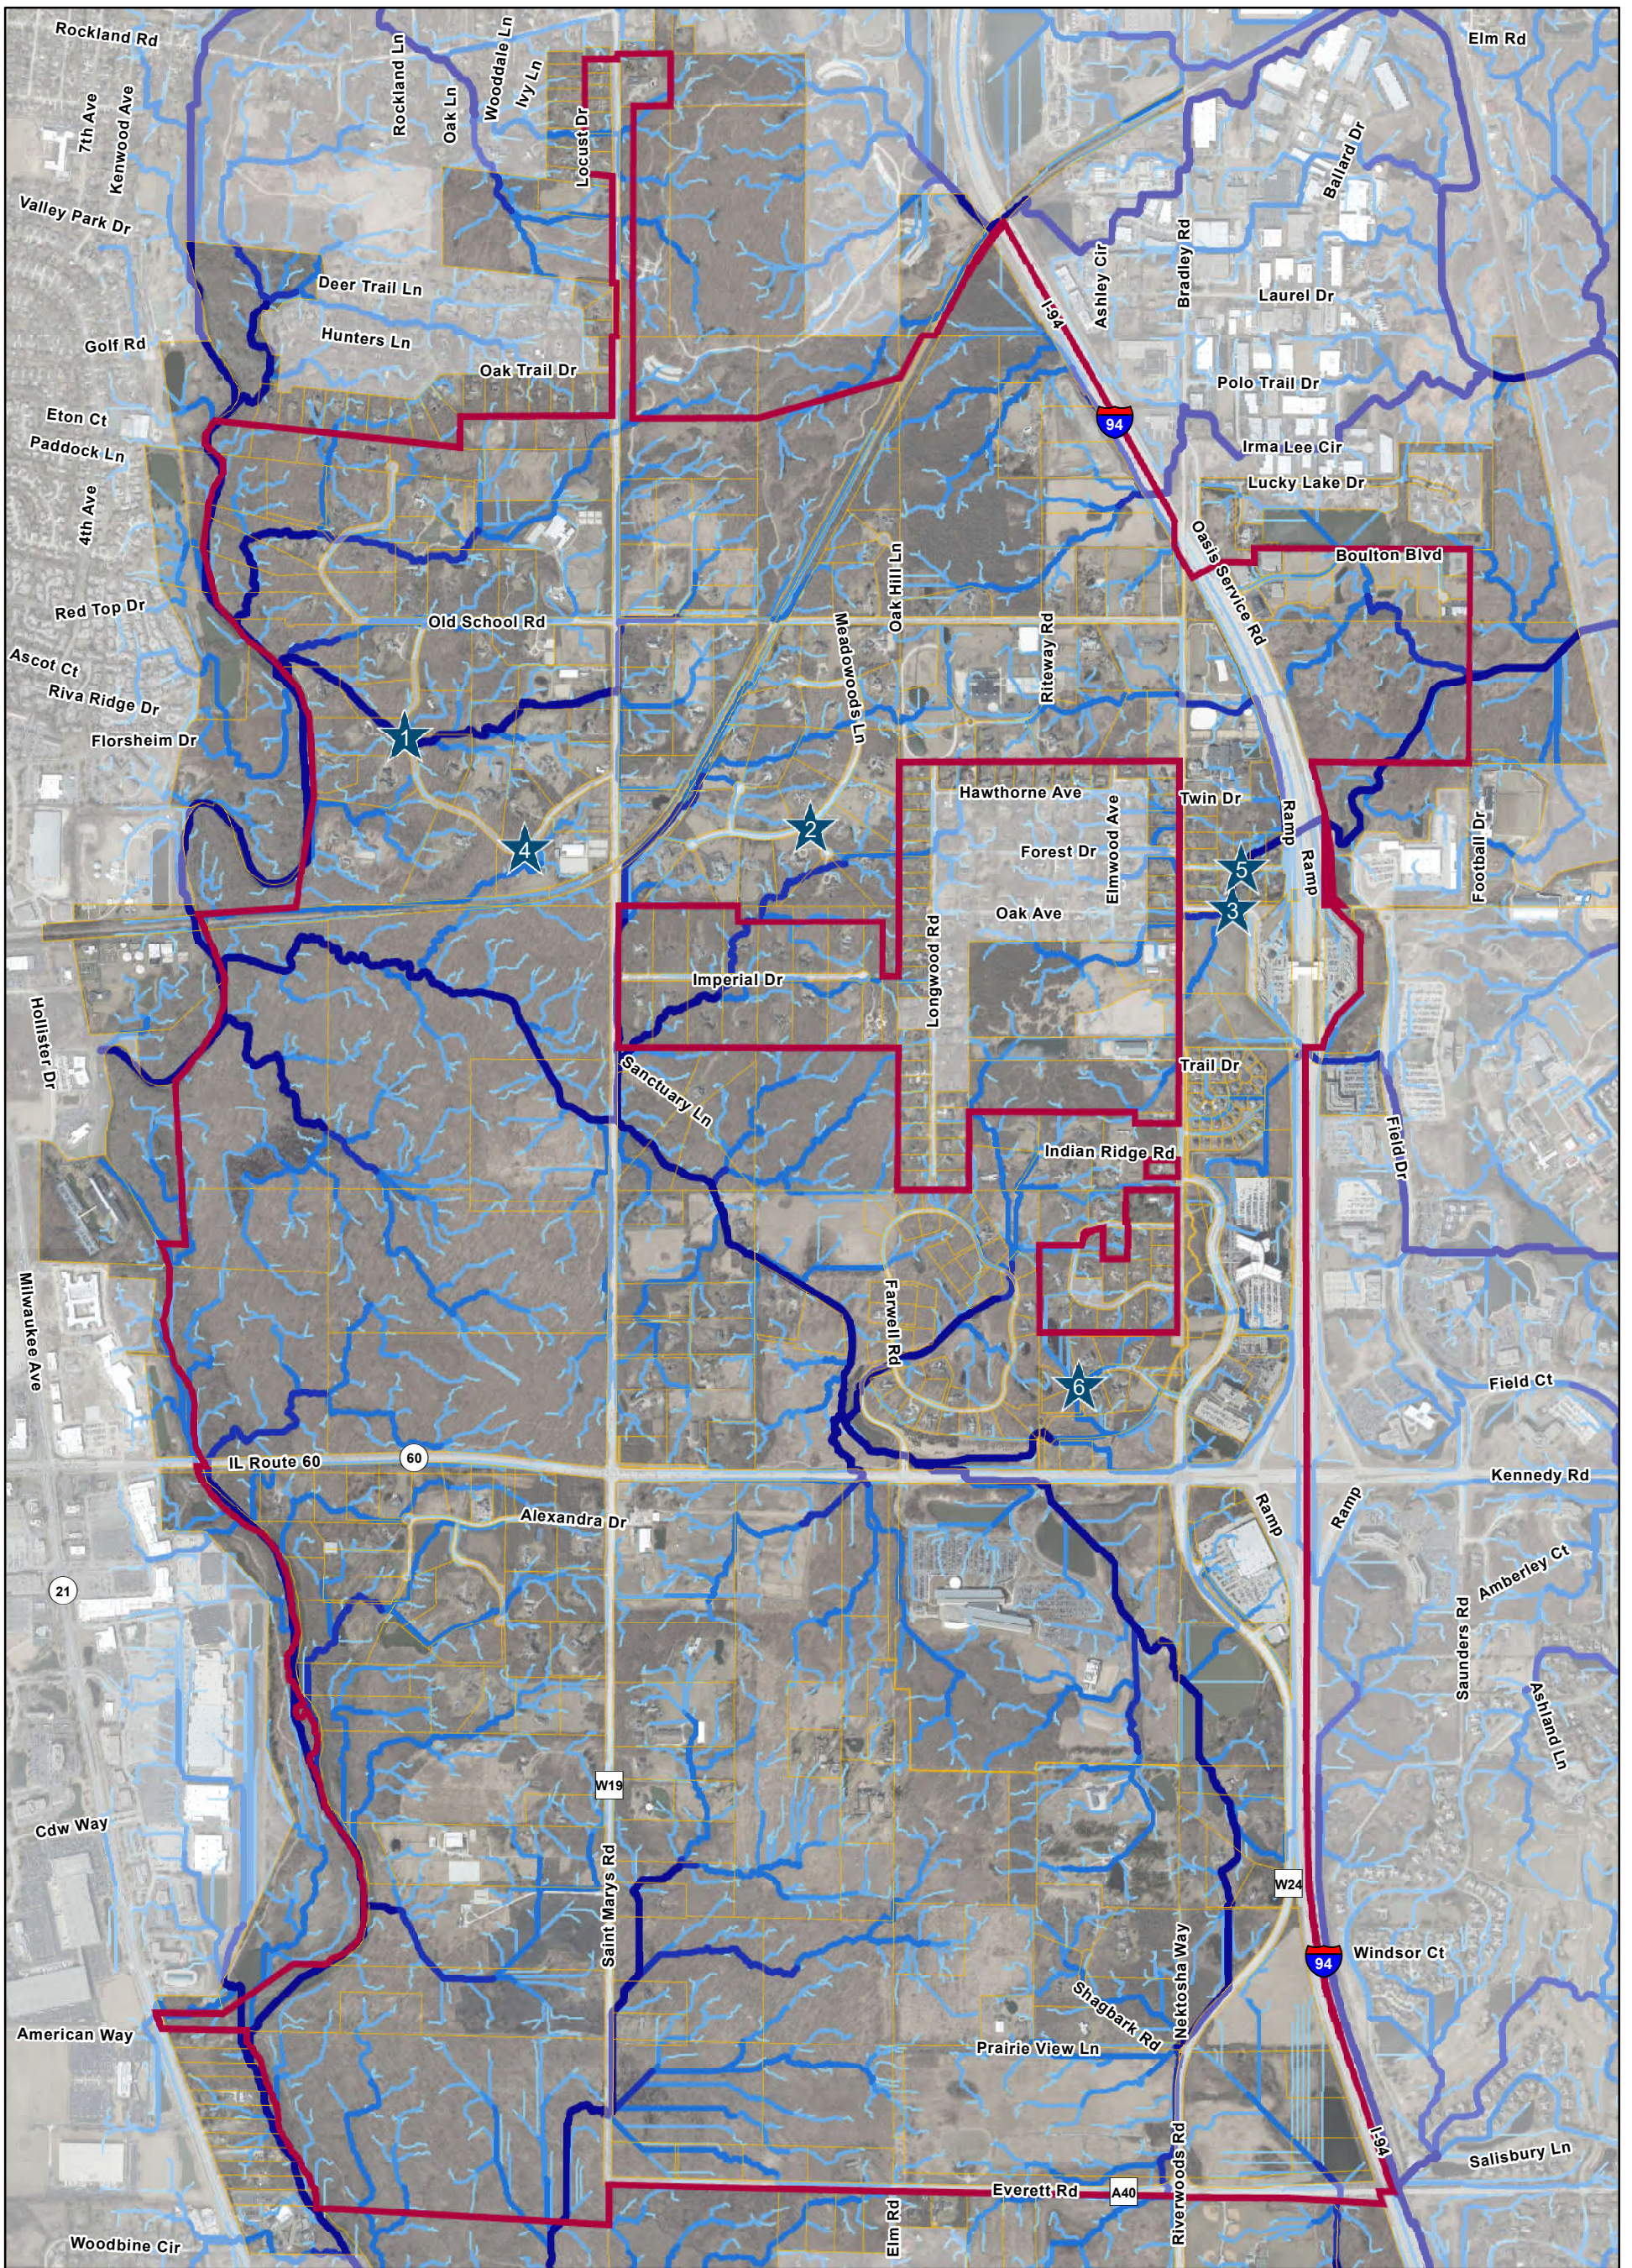
Project Name:
Drainage Study
 Prepared for:
Village of Mettawa
 Information about exhibit:
 Delineated using County LiDAR DEM
 Exhibit Title: **Flowpath Analysis** Exhibit: **3**

Flowpaths (Contributing Area)
 — 0.5 - 1ac
 — 1 - 5ac
 — 5 - 10ac
 — 10 - 50ac
 — 50 - 100ac
 — > 100ac

Further processing derived linear features to delineate drainageways as part of the flowpath mapping. This process involves calculating flow direction by analyzing raster cell elevation values to create a “flow direction” raster, and calculating flow accumulation by analyzing the output of the flow direction analysis. The resulting series of calculations provides a raster layer in which each cell is coded with the number of cells “flowing” to it, and resulting contributing areas can be calculated using the cell size. Similar to the depressional storage area analysis, thorough evaluation of this product aided in understanding sources and extents of drainage issues and informed concept solution development. Results are classified as 0.5 - 1-acre, 1 - 5-acres, 5 - 10-acres, 10 - 50-acres, 50 - 100-acres, and greater than 100-acres contributing area ranges as shown on Exhibit 3.
